# **Selected Images of the Effects of the October 15, 2006, Kīholo Bay-Māhukona, Hawai‘i, Earthquakes and Recovery Efforts**

Data Series 506

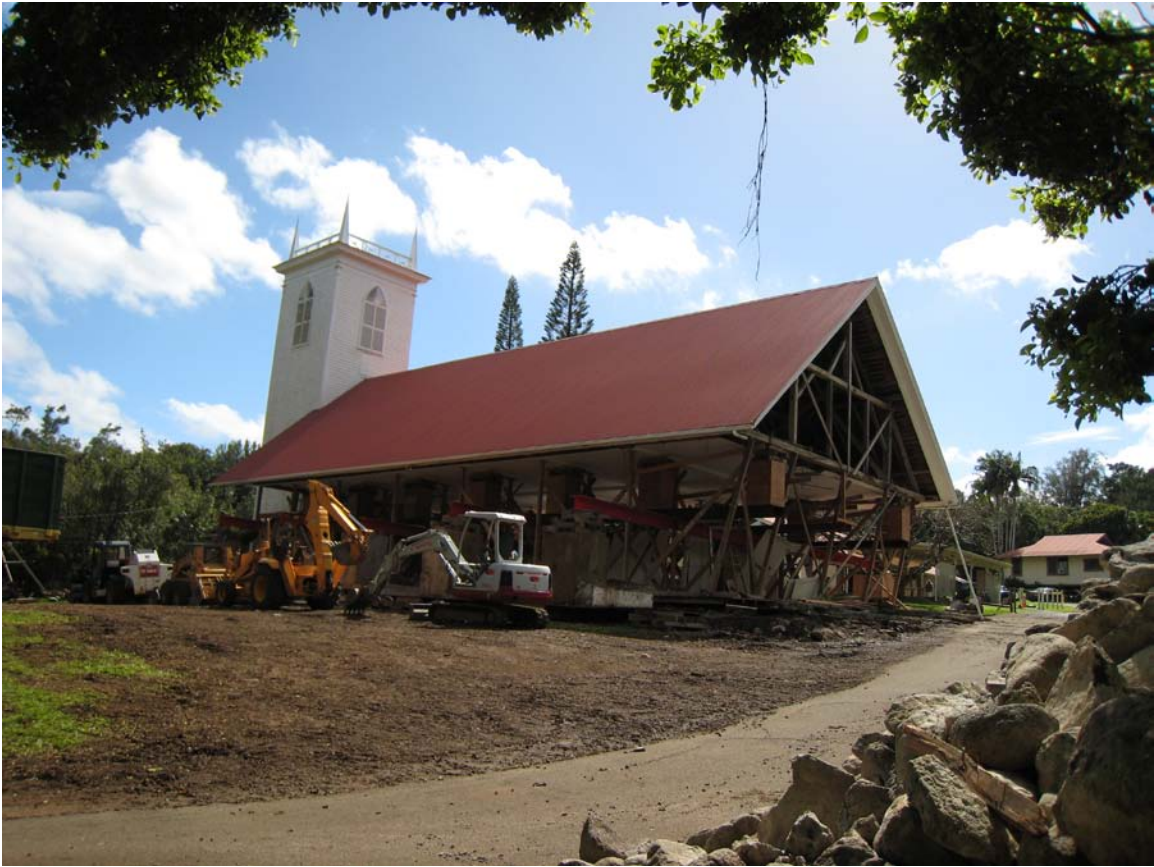
24.17. View of stones from the collapsed walls of the church, carefully piled beside the driveway for later use in a stone wall around the church (view to the south-southwest). USGS photo by T.J. Takahashi, 1/17/2009 (tjt964).

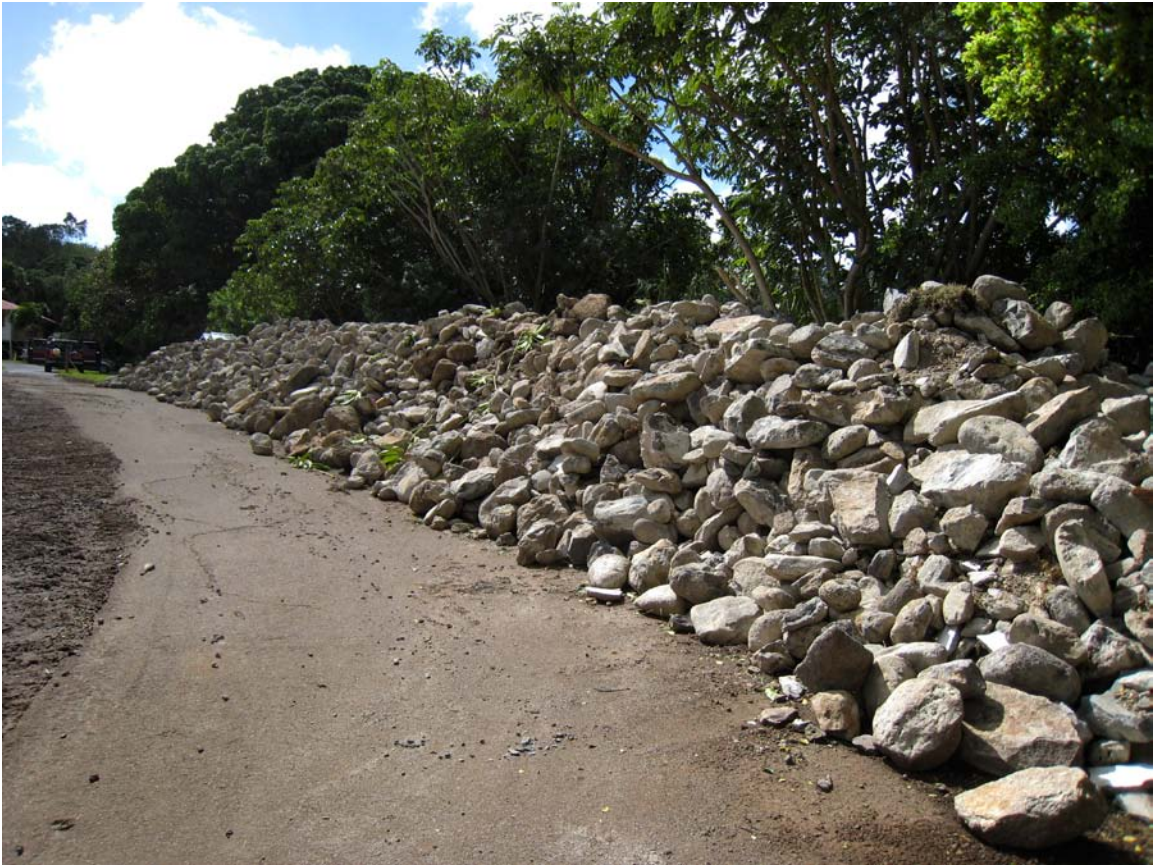
24.18. View of the dried-out mortar, which contributed to the walls' collapse (view to the west). USGS photo by T.J. Takahashi, 1/17/2009 (tjt970).

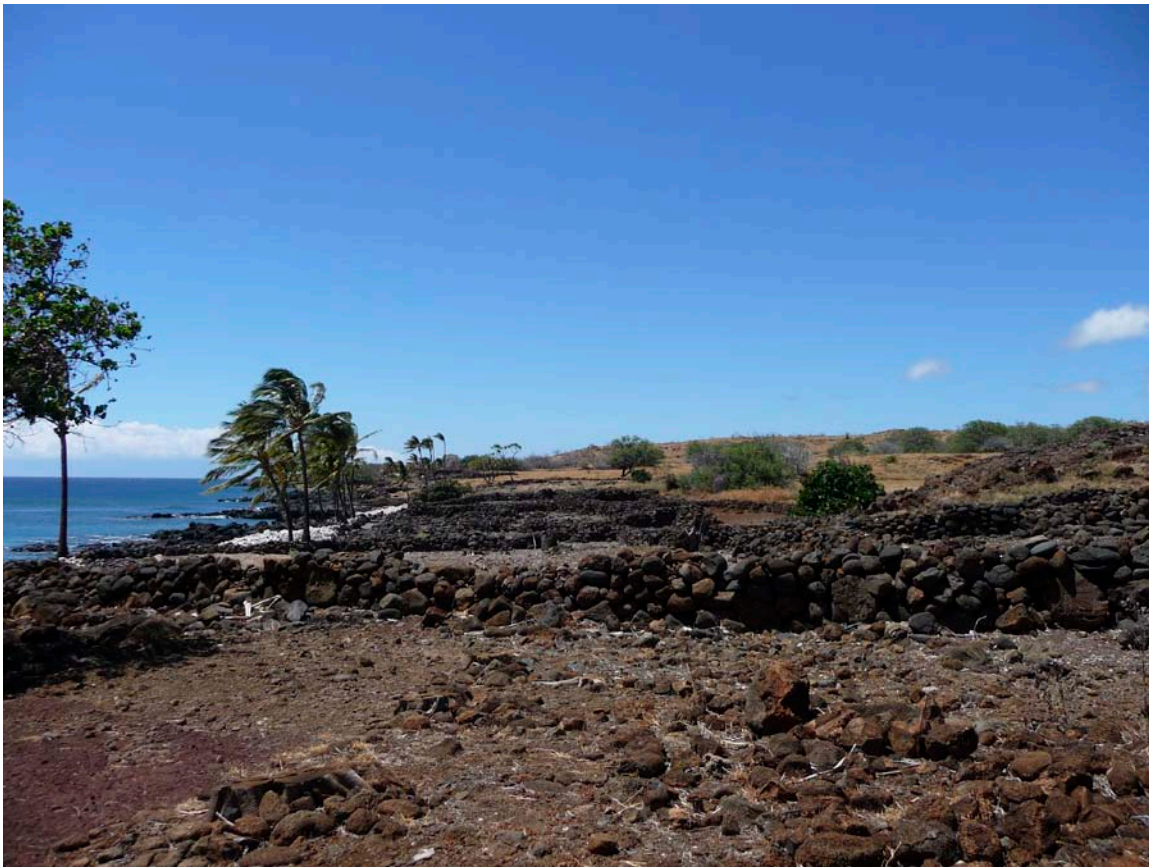
25.4. View of the collapsed stacked-rock walls of a house site (view to the northwest).  
USGS photo by N.A. Ikeda, 7/11/2008 (nai616).

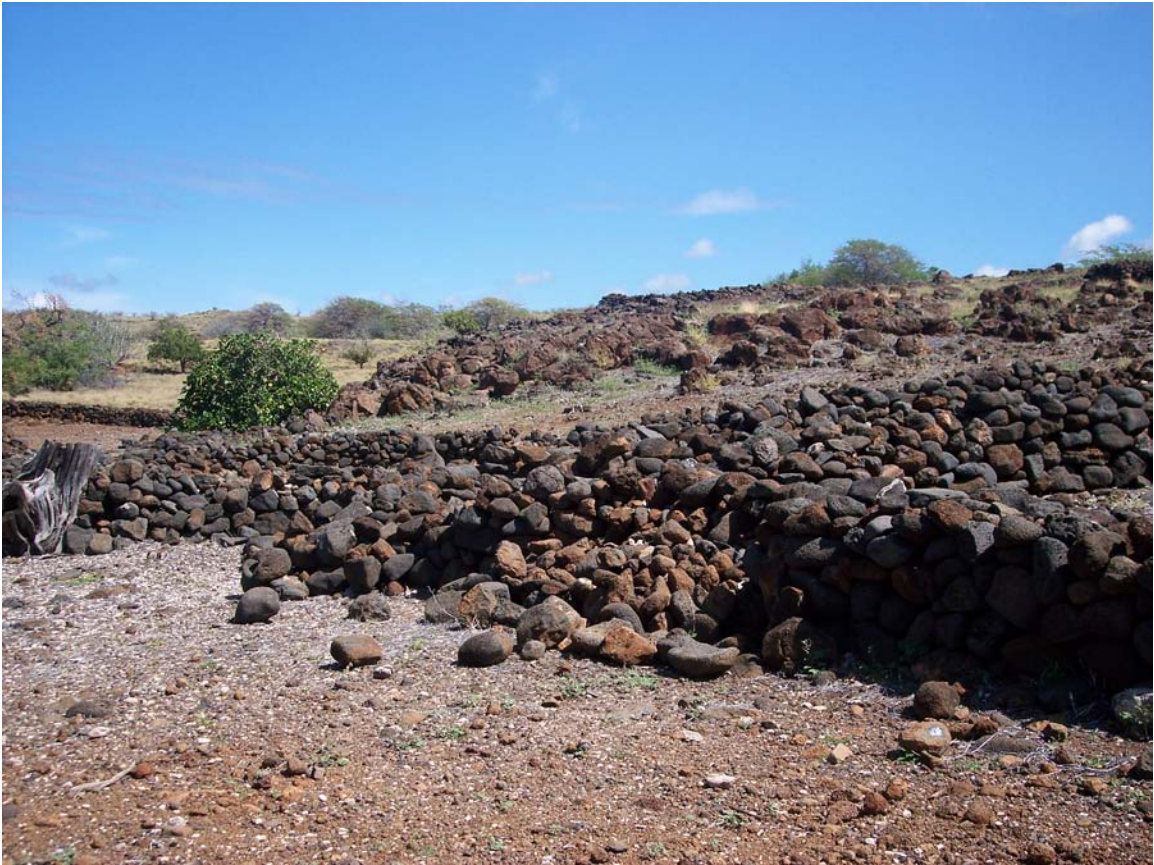
25.5. View of the collapsed rock wall of a house site (view to the northwest). USGS photo by T.J. Takahashi, 3/3/2007 (tjt2825).

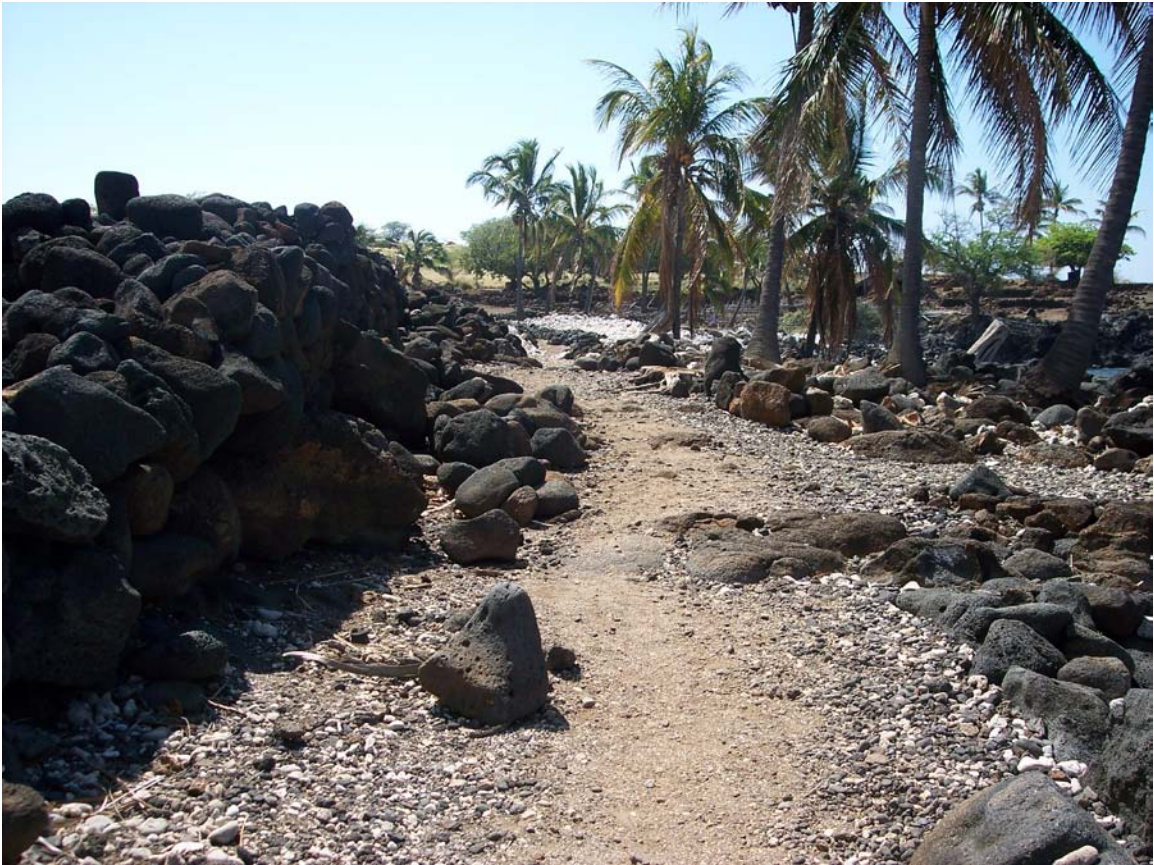
25.6. View of a collapsed rock wall along the coastal trail (view to the southeast). USGS photo by T.J. Takahashi, 3/3/2007 (tjt2819).

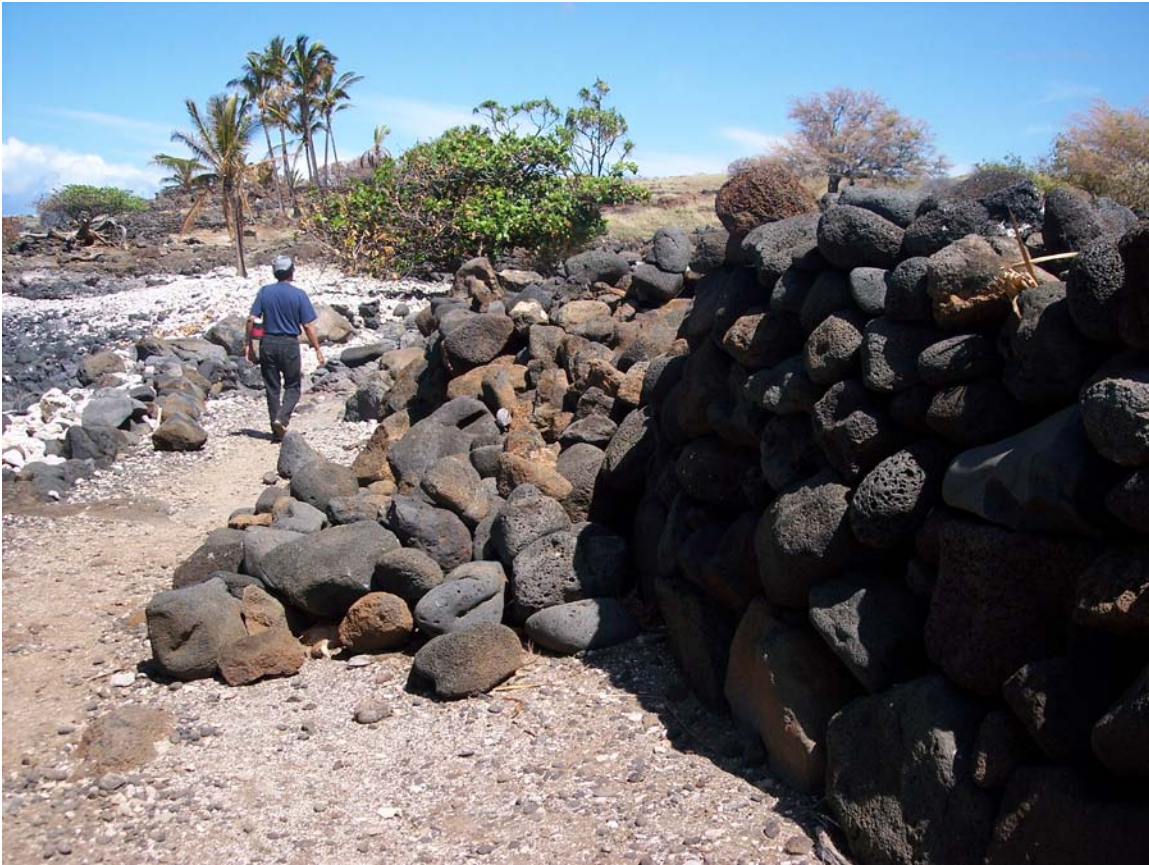
25.7. View of a partially collapsed rock wall along the coastal trail (view to the north-northwest). USGS photo by T.J. Takahashi, 3/3/2007 (tjt2860).

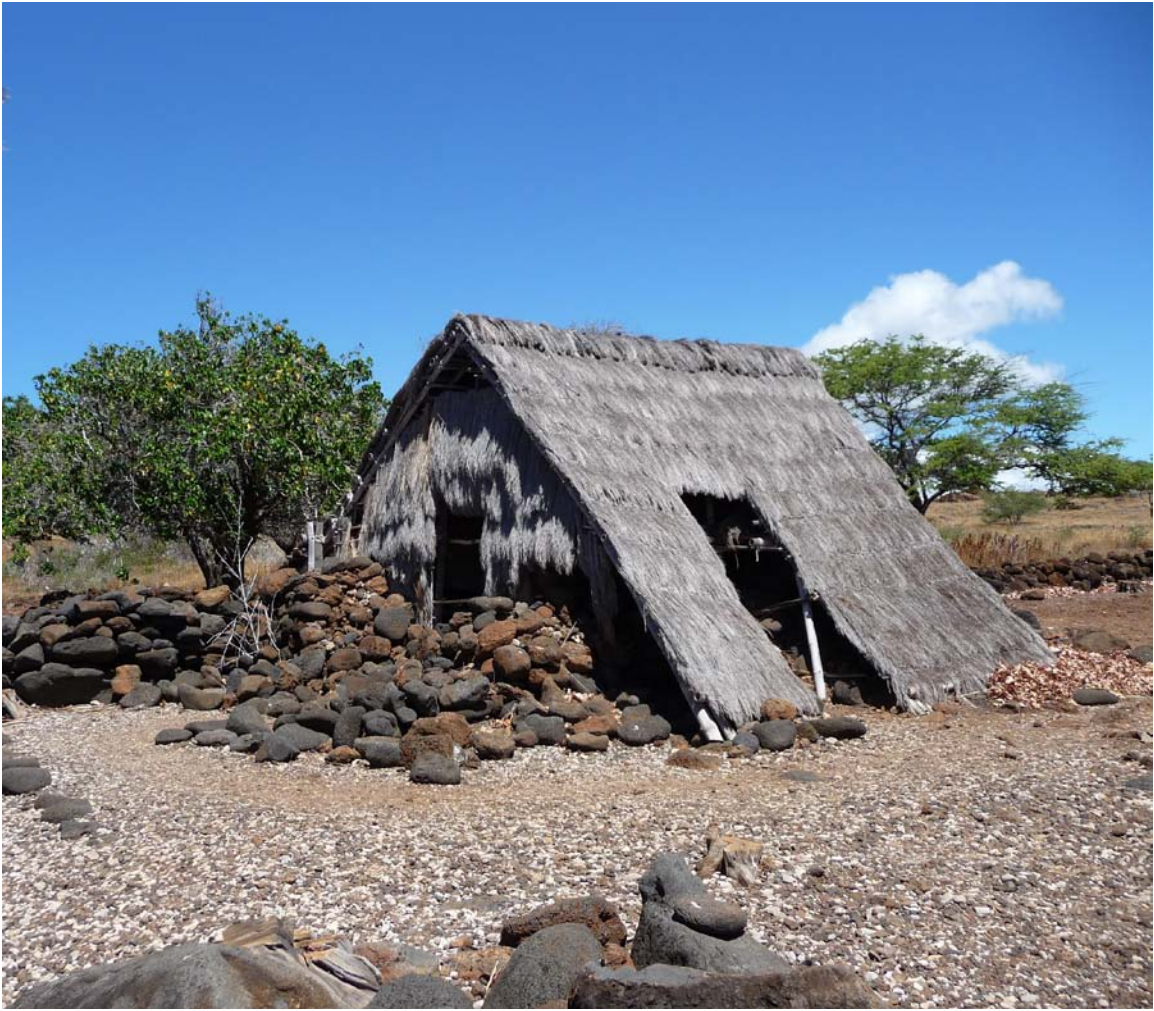
25.8. View of the collapsed rock wall in front of a Hawaiian thatched house (view to the north). USGS photo by N.A. Ikeda, 7/11/2008 (nai619).

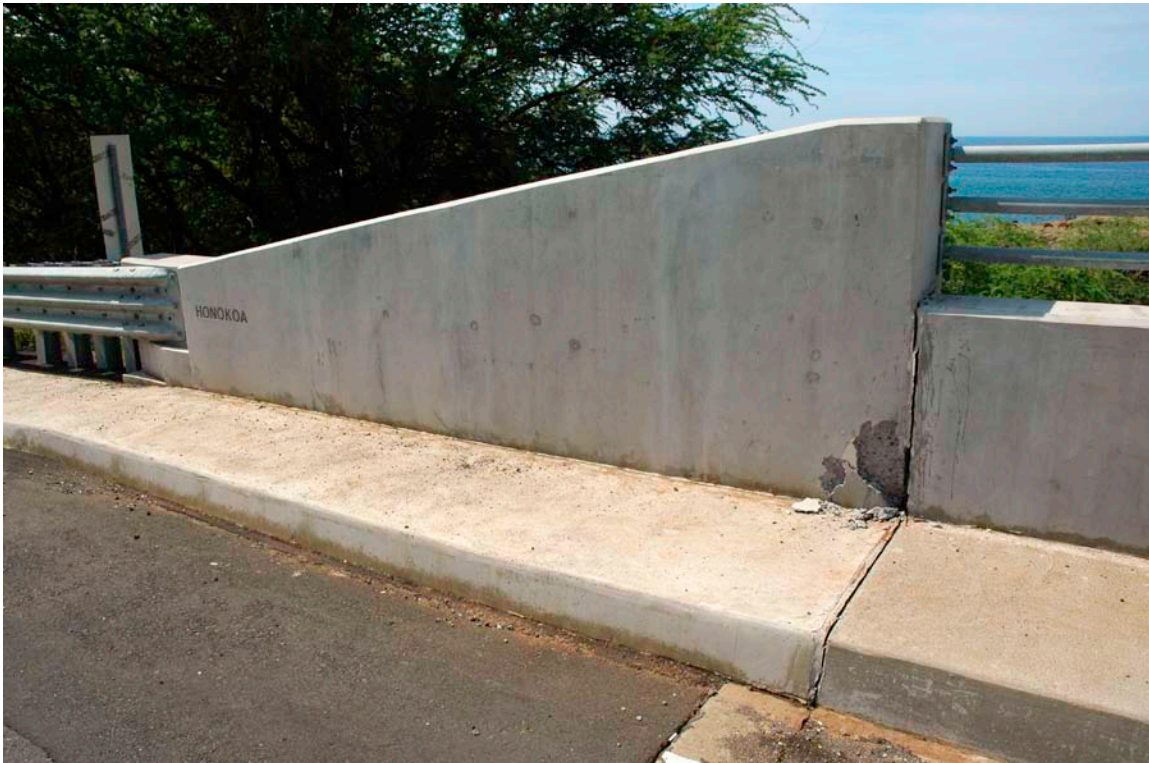
26.1. View of the spalled (chipped) concrete guardrail and separated walkway and pavement at Honokoa Bridge (view to the southwest). CSAV photo by D.A. Whilldin, 10/20/2006 (daw073).

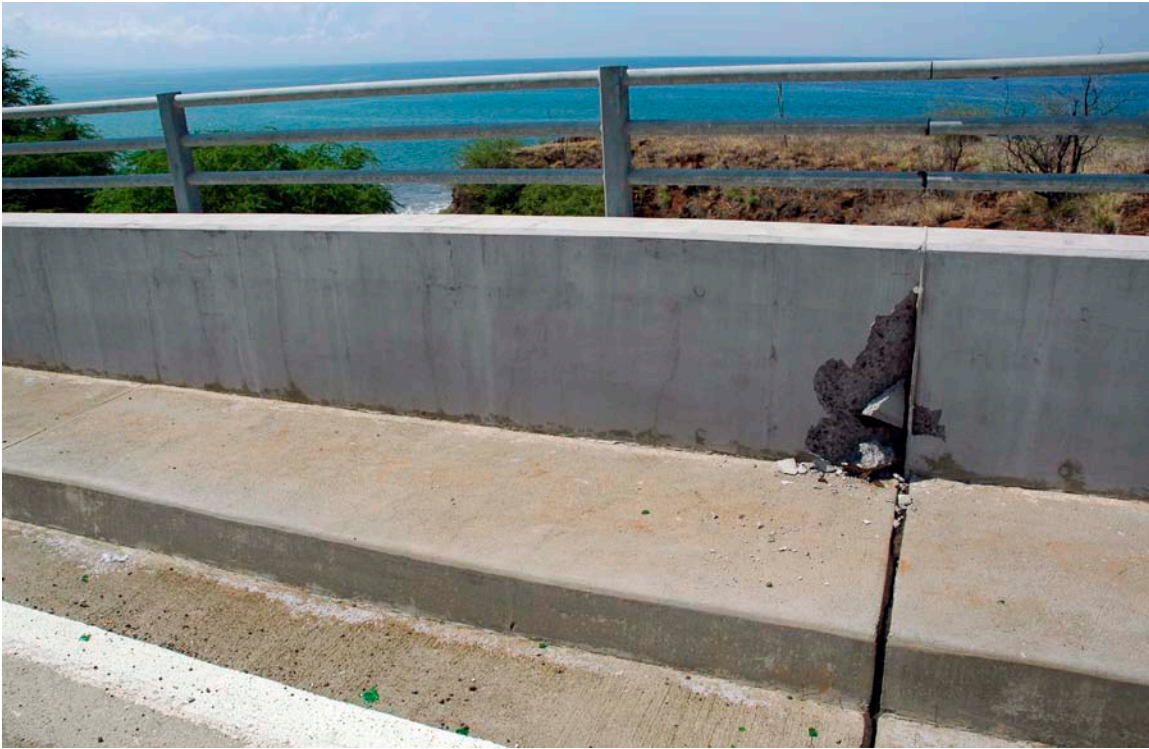
26.2. View of another section of the spalled concrete guardrail and separated walkway and pavement at Honokoa Bridge (view to the southwest). CSAV photo by D.A. Whilldin, 10/20/2006 (daw076).

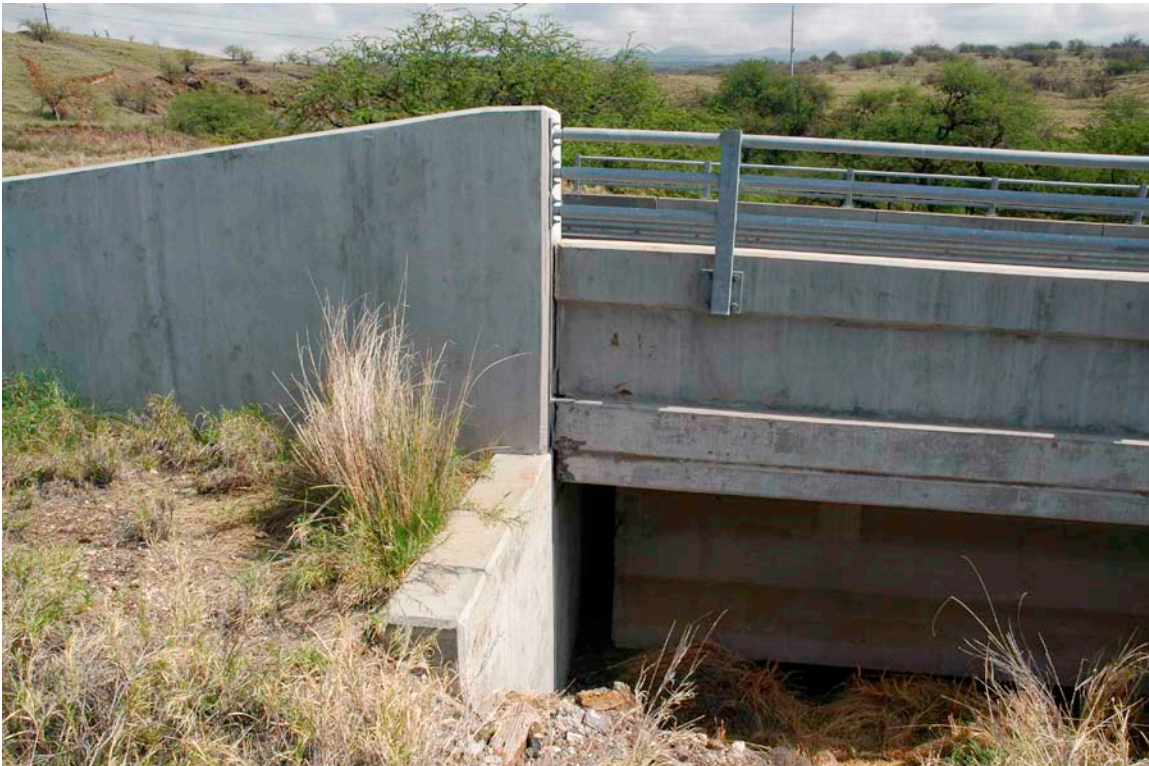
26.3. View of separation in the concrete guardrail (view to the northeast). CSAV photo by D.A. Whilldin, 10/20/2006 (daw080).

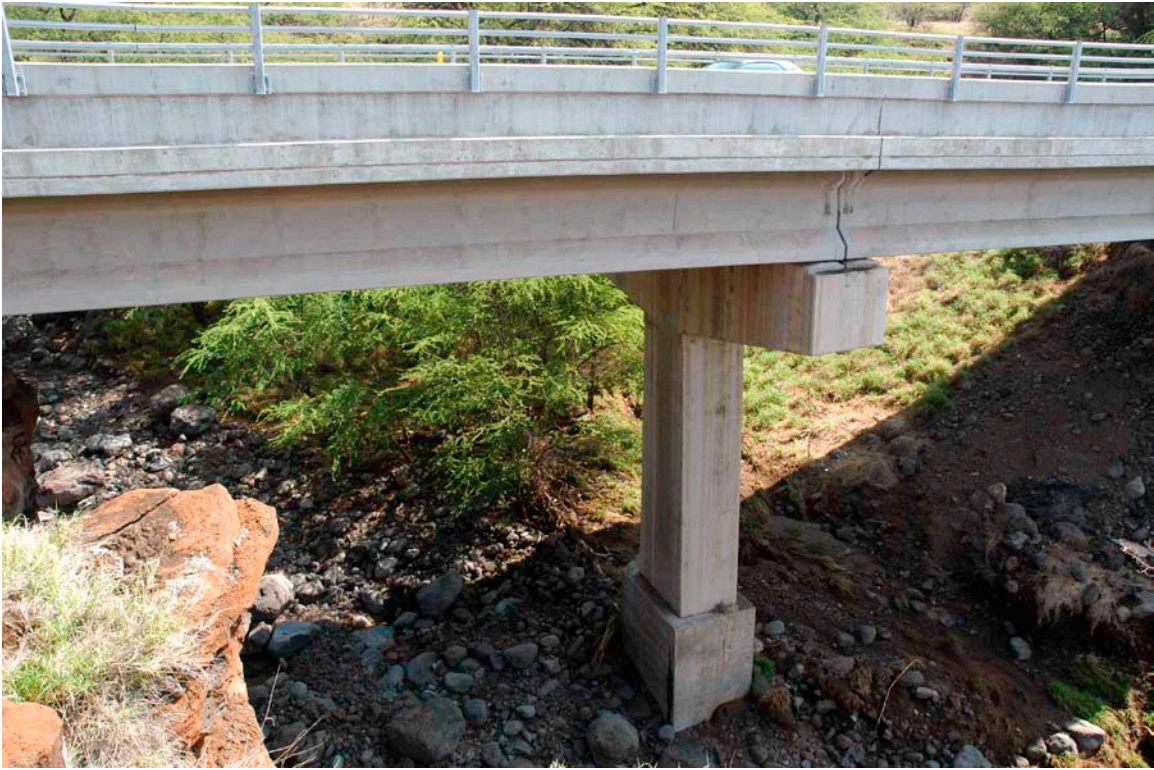
26.4. View of separation in the bridge above the supporting pillar (view to the east). CSAV photo by D.A. Whilldin, 10/20/2006 (daw016).

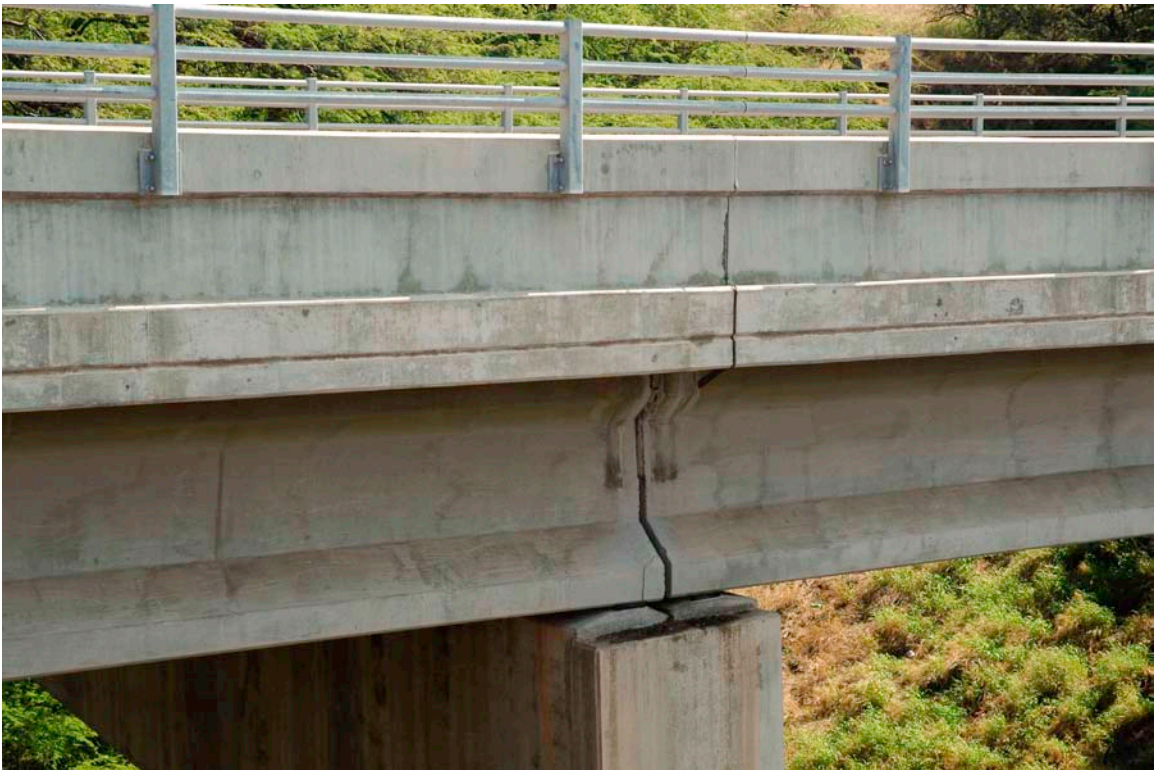
26.5. Close-up view of separation in the bridge above the supporting pillar (view to the east). CSAV photo by D.A. Whilldin, 10/20/2006 (daw084).

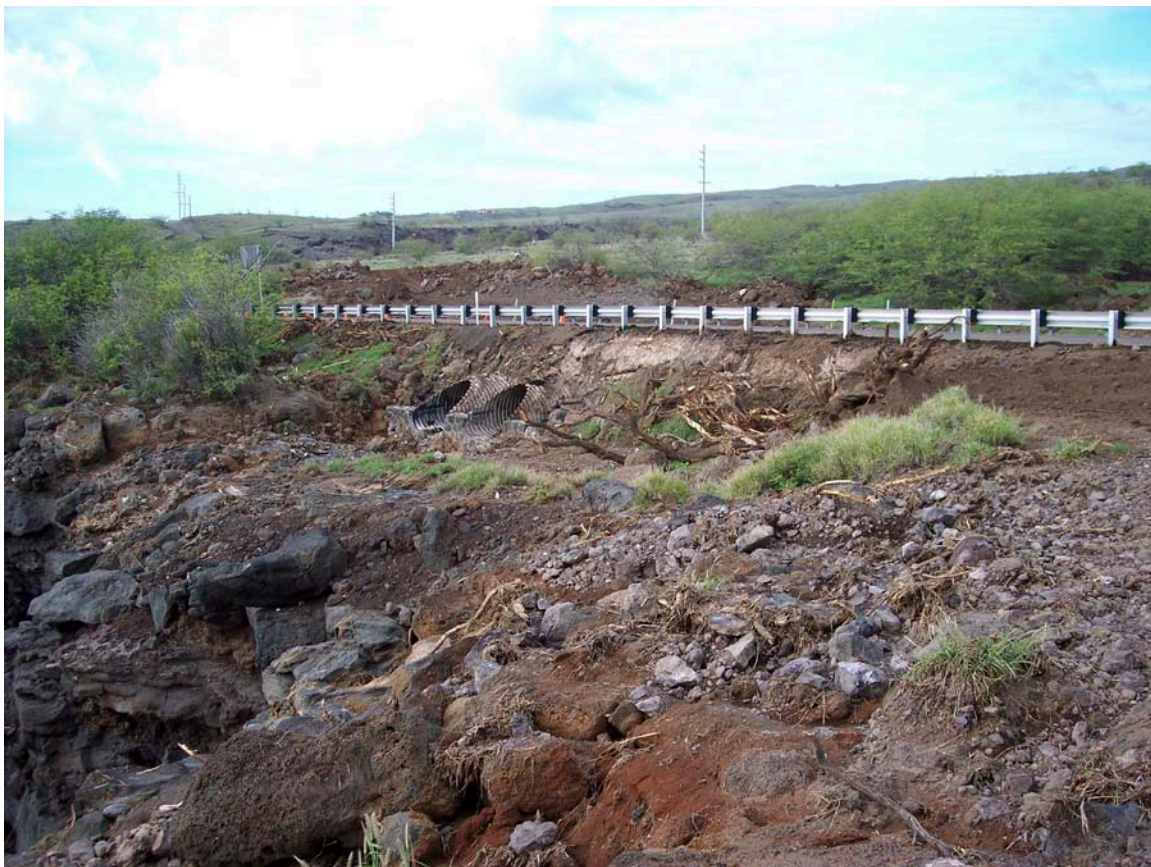
27.1. View of the slump in the road fill at Honokoa Gulch. Note two culverts at center left of the image (view to the north-northeast). USGS photo by T.J. Takahashi, 10/21/2006 (tjt1540fl).

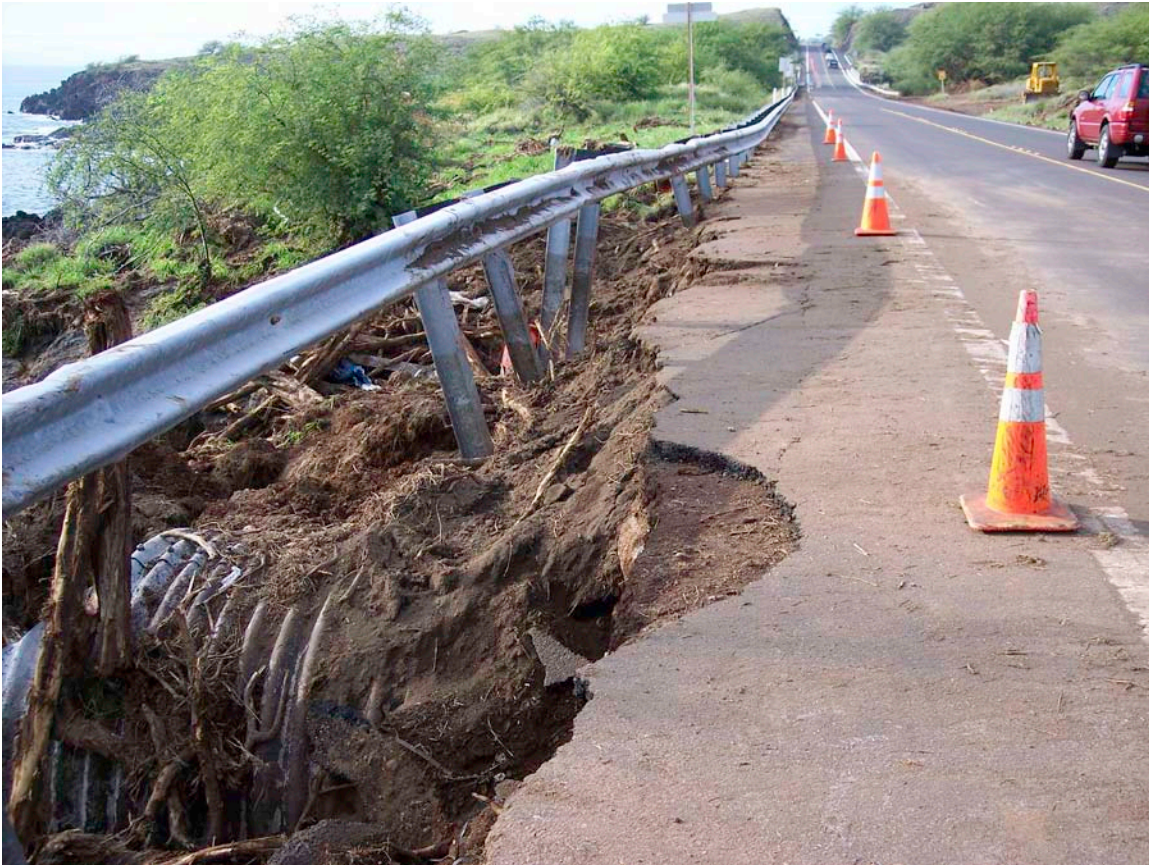
27.2. View of the failed shoulder and damage to the culverts at Honokoa Gulch (view to the northwest). USGS photo by T.J. Takahashi, 10/21/2006 (tjt1563).

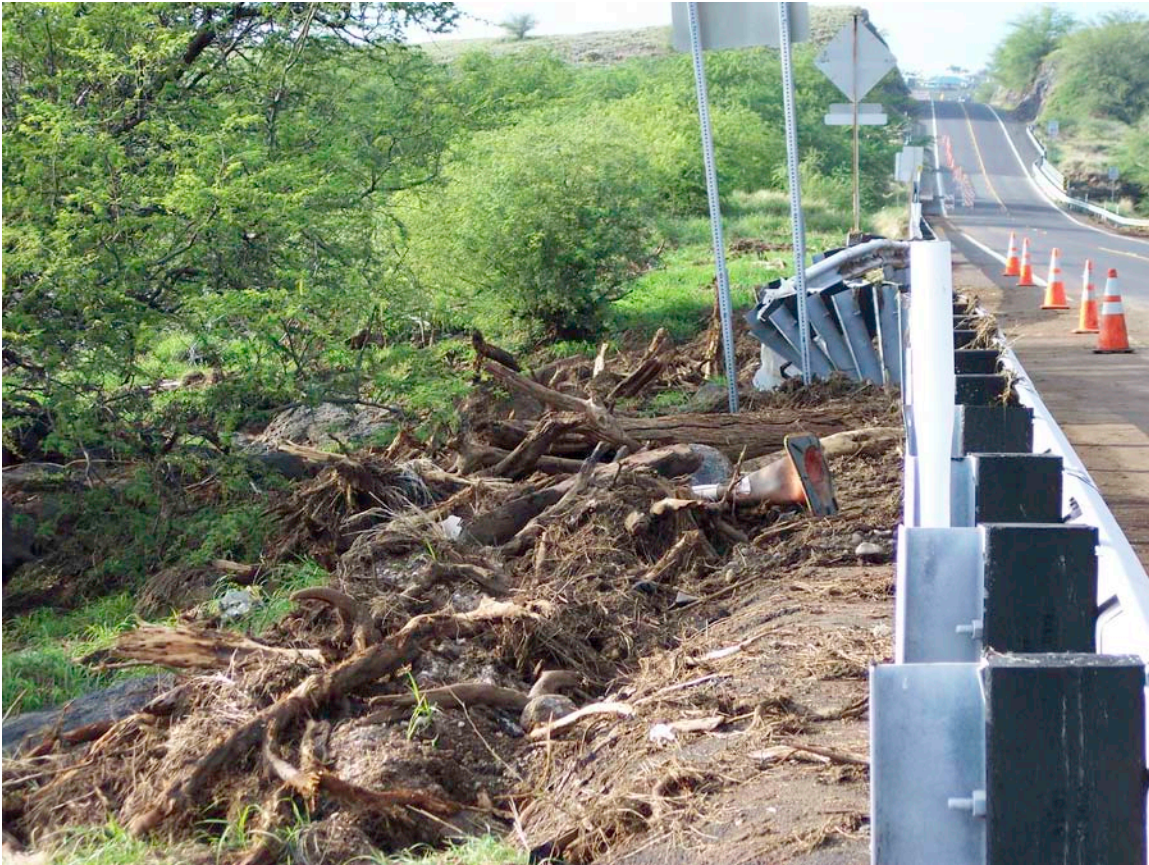
27.3. View of the damage to the railing from fill failure and flooding, which washed the debris of uprooted trees and boulders across the highway the day after the earthquakes (view to the northwest). USGS photo by T.J. Takahashi, 10/21/2006 (tjt1558).

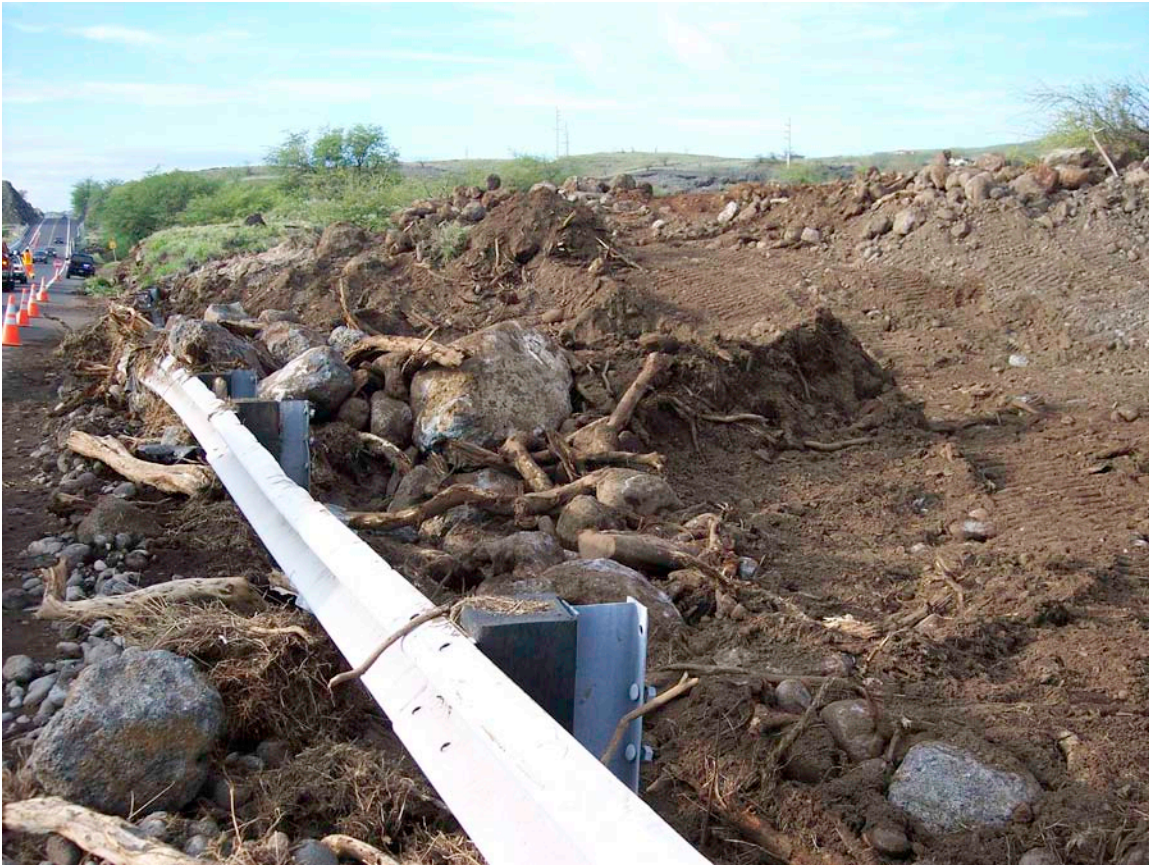
27.4. View of regrading after earth, boulders, and tree branches piled up at the guardrail. Much of the debris was held back by the guardrail, but some tree branches and rocks overtopped the railing and were washed to the seaward side of the highway (view to the north). USGS photo by T.J. Takahashi, 10/21/2006 (tjt1584).

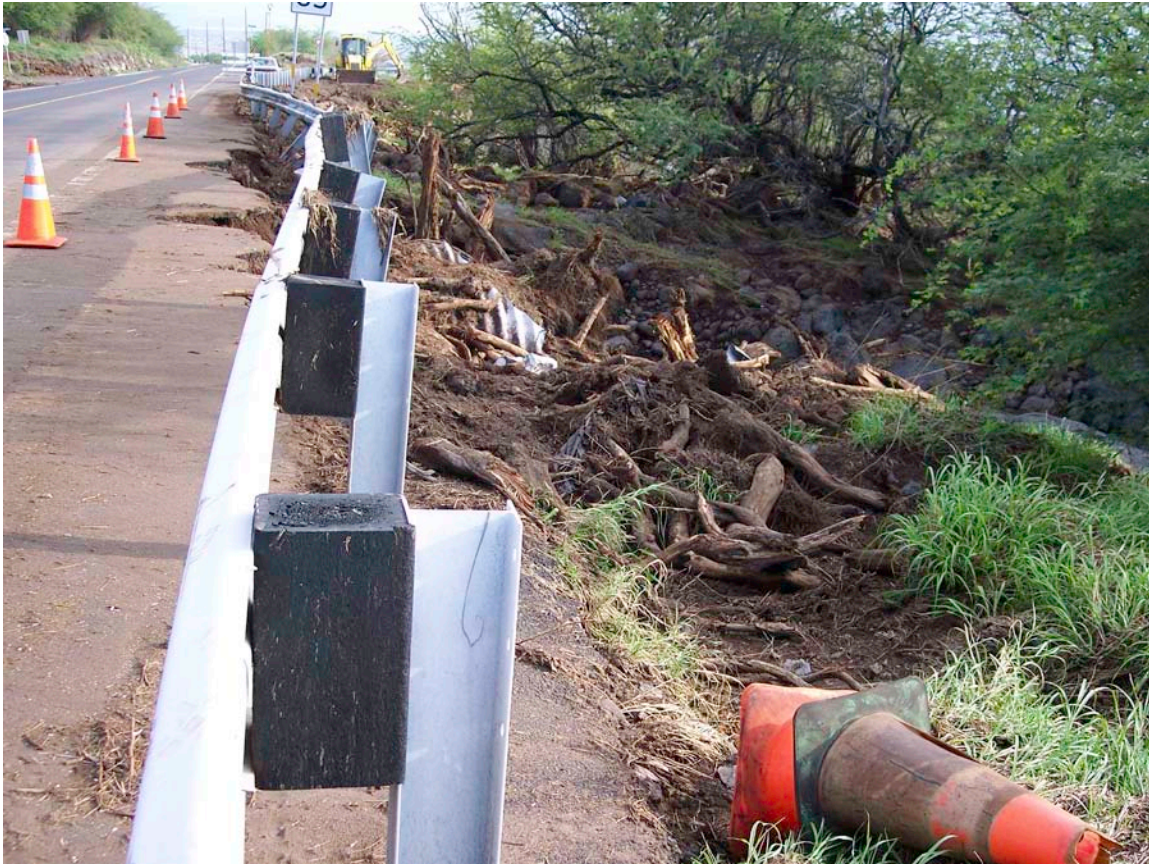
27.5. View of the collapsed shoulder, damaged railing, and debris of uprooted trees and rocks, which resulted in the blockage of Highway 270 (view to the southeast). USGS photo by T.J. Takahashi, 10/21/2006 (tjt1572).

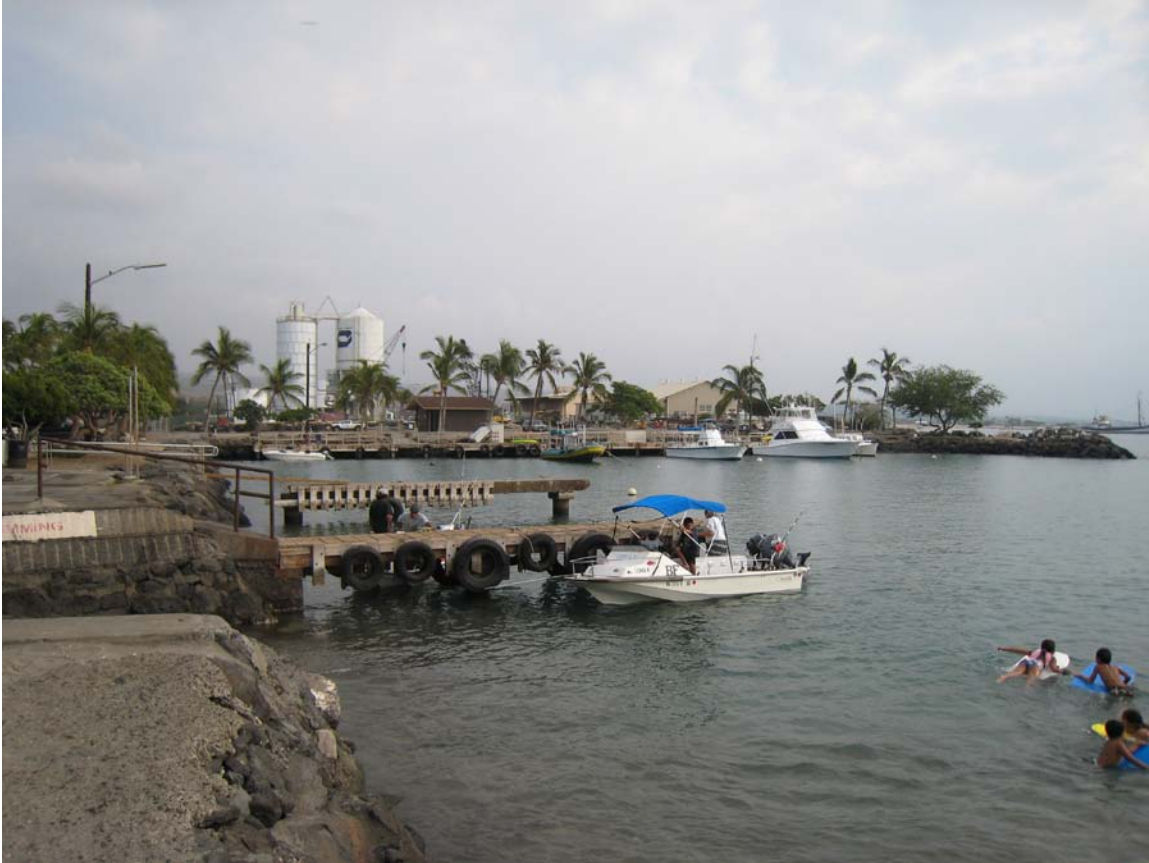
28.1. *Overview image*: Kawaihae Small Boat Harbor sustained much damage as a result of the earthquake. Children play on their boogie boards, and a couple of boats tie up to Loading Dock Number 1 in the foreground, lined with old tires. The dock is attached to the boat-launching ramp (to the left in the photo), hidden by a rock wall in the foreground. Behind Loading Dock Number 1 in the photo is Loading Dock Number 2, the smaller of the two. The marginal wharf is in the background; the southeast side of the breakwater extends beyond it (near the right edge of the photo). Beyond the dark brown comfort station are the twin towers of Kawaihae Pier (view to the east-southeast). USGS photo by T.J. Takahashi, 11/28/2008 (tjt698).

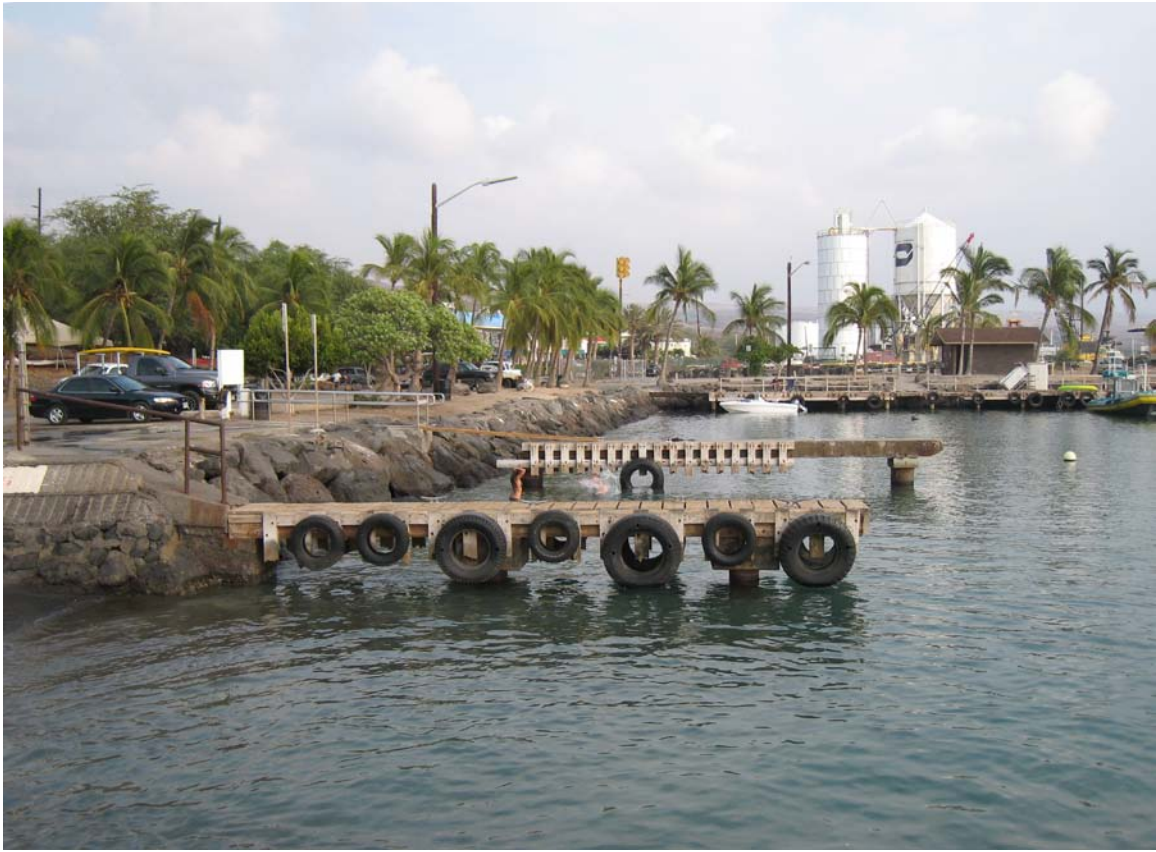
28.2. *Overview image:* Loading Docks 1 (with 7 tire bumpers) and 2 (with one tire bumper) at North Kawaihae Small Boat Harbor. The rock revetment wall fronting the parking area (to the left in the photo) slumped and moved seaward when the earthquake occurred (view to the east-southeast). USGS photo by T.J. Takahashi, 11/28/2008 (tjt718).

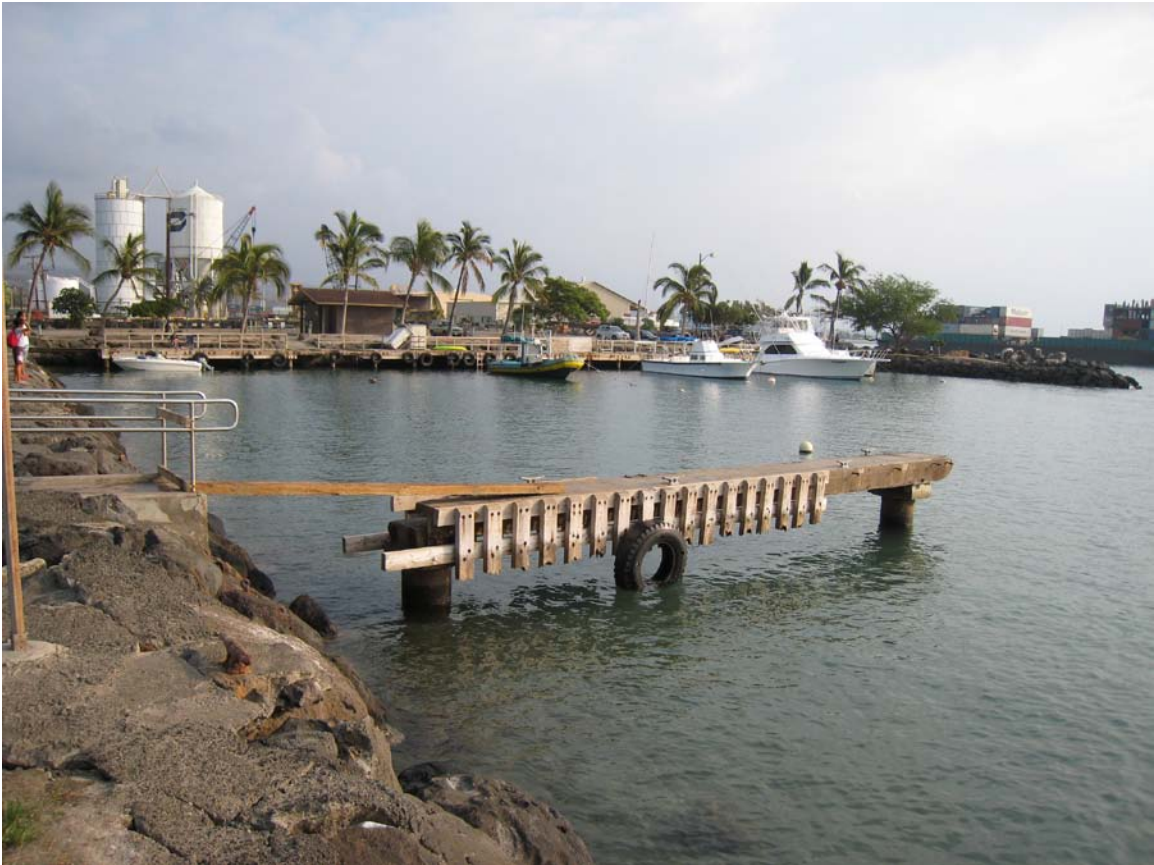
28.3. View of the conventional entry into the water at Loading Dock Number 2, blocked at the end of the handrail (to the left in the photo); but the dock is linked to the seawall by a new makeshift wooden plank, replacing the previous one that failed (view to the east-southeast). USGS photo by T.J. Takahashi, 11/28/2008 (tjt730).

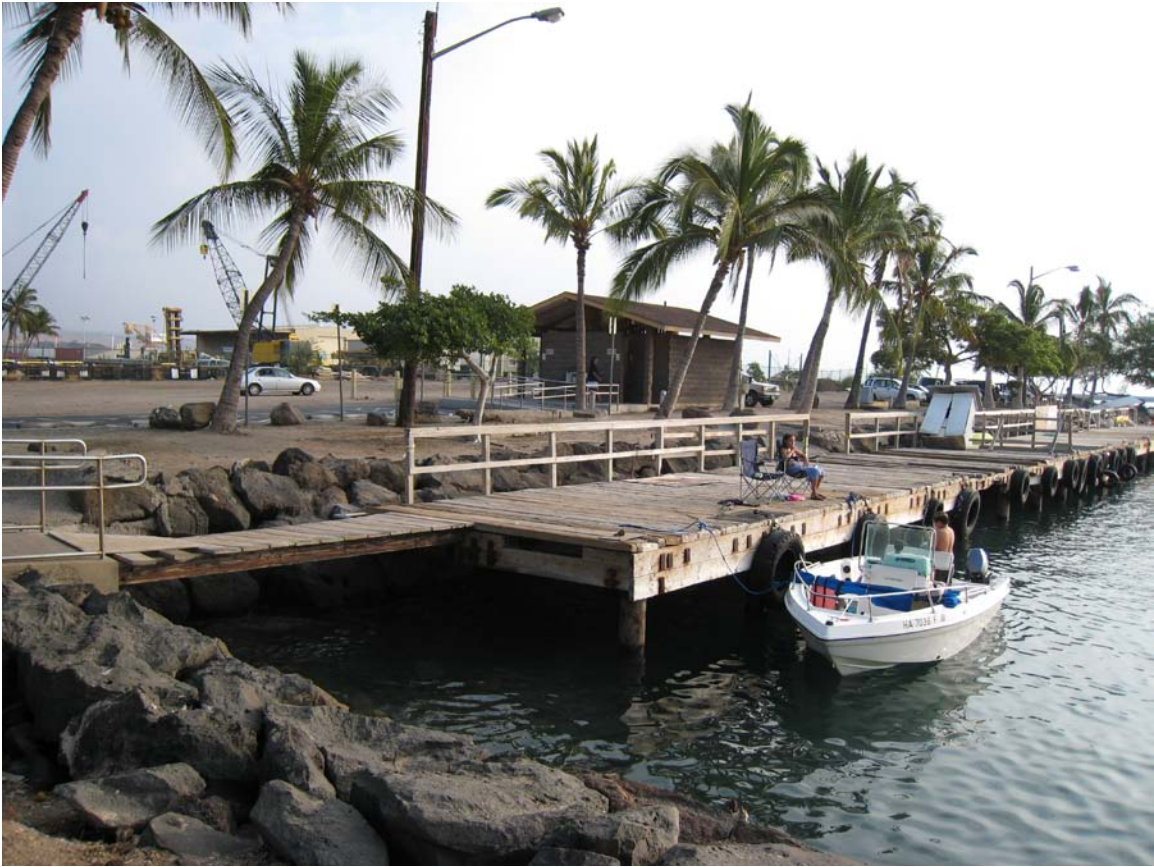
28.8. *Overview image:* View of the marginal wharf, with the rock revetment wall behind it. The railing (at the left edge of the photo) is built upon a concrete slab attached to the wooden walkway. The entire platform of the wharf is in disrepair from previous damage and is periodically repaired (view to the south). USGS photo by T.J. Takahashi, 11/28/2008 (tjt744).

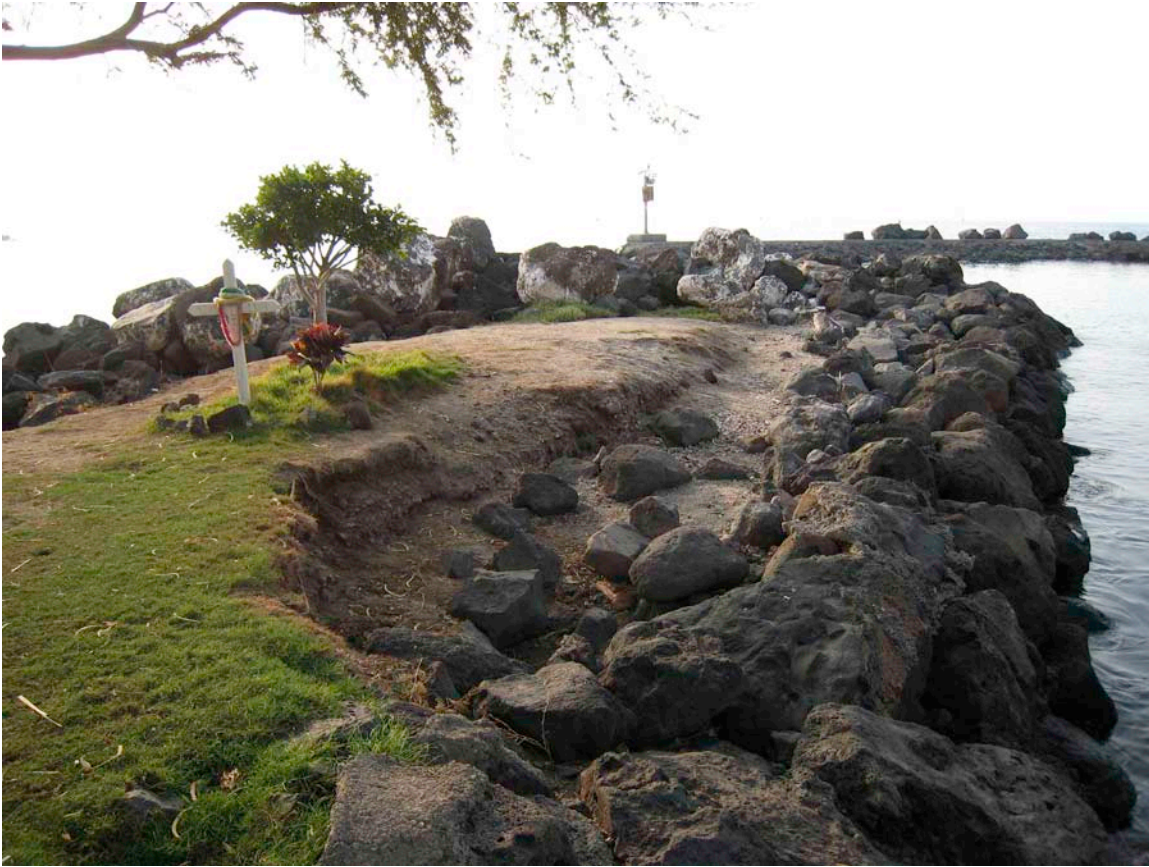
28.10. View of slumping of the ground along the rock revetment seawall (view to the west-northwest). USGS photo by T.J. Takahashi, 11/28/2008 (tjt780).
